NATIONAL BUREAU OF STANDARDS REPORT

INVESTIGATION OF THE DIRECTIONAL EFFECTS IN THE STRESS CORROSION OF ALUMINUM ALLOYS

Final Report

April 22, 1968

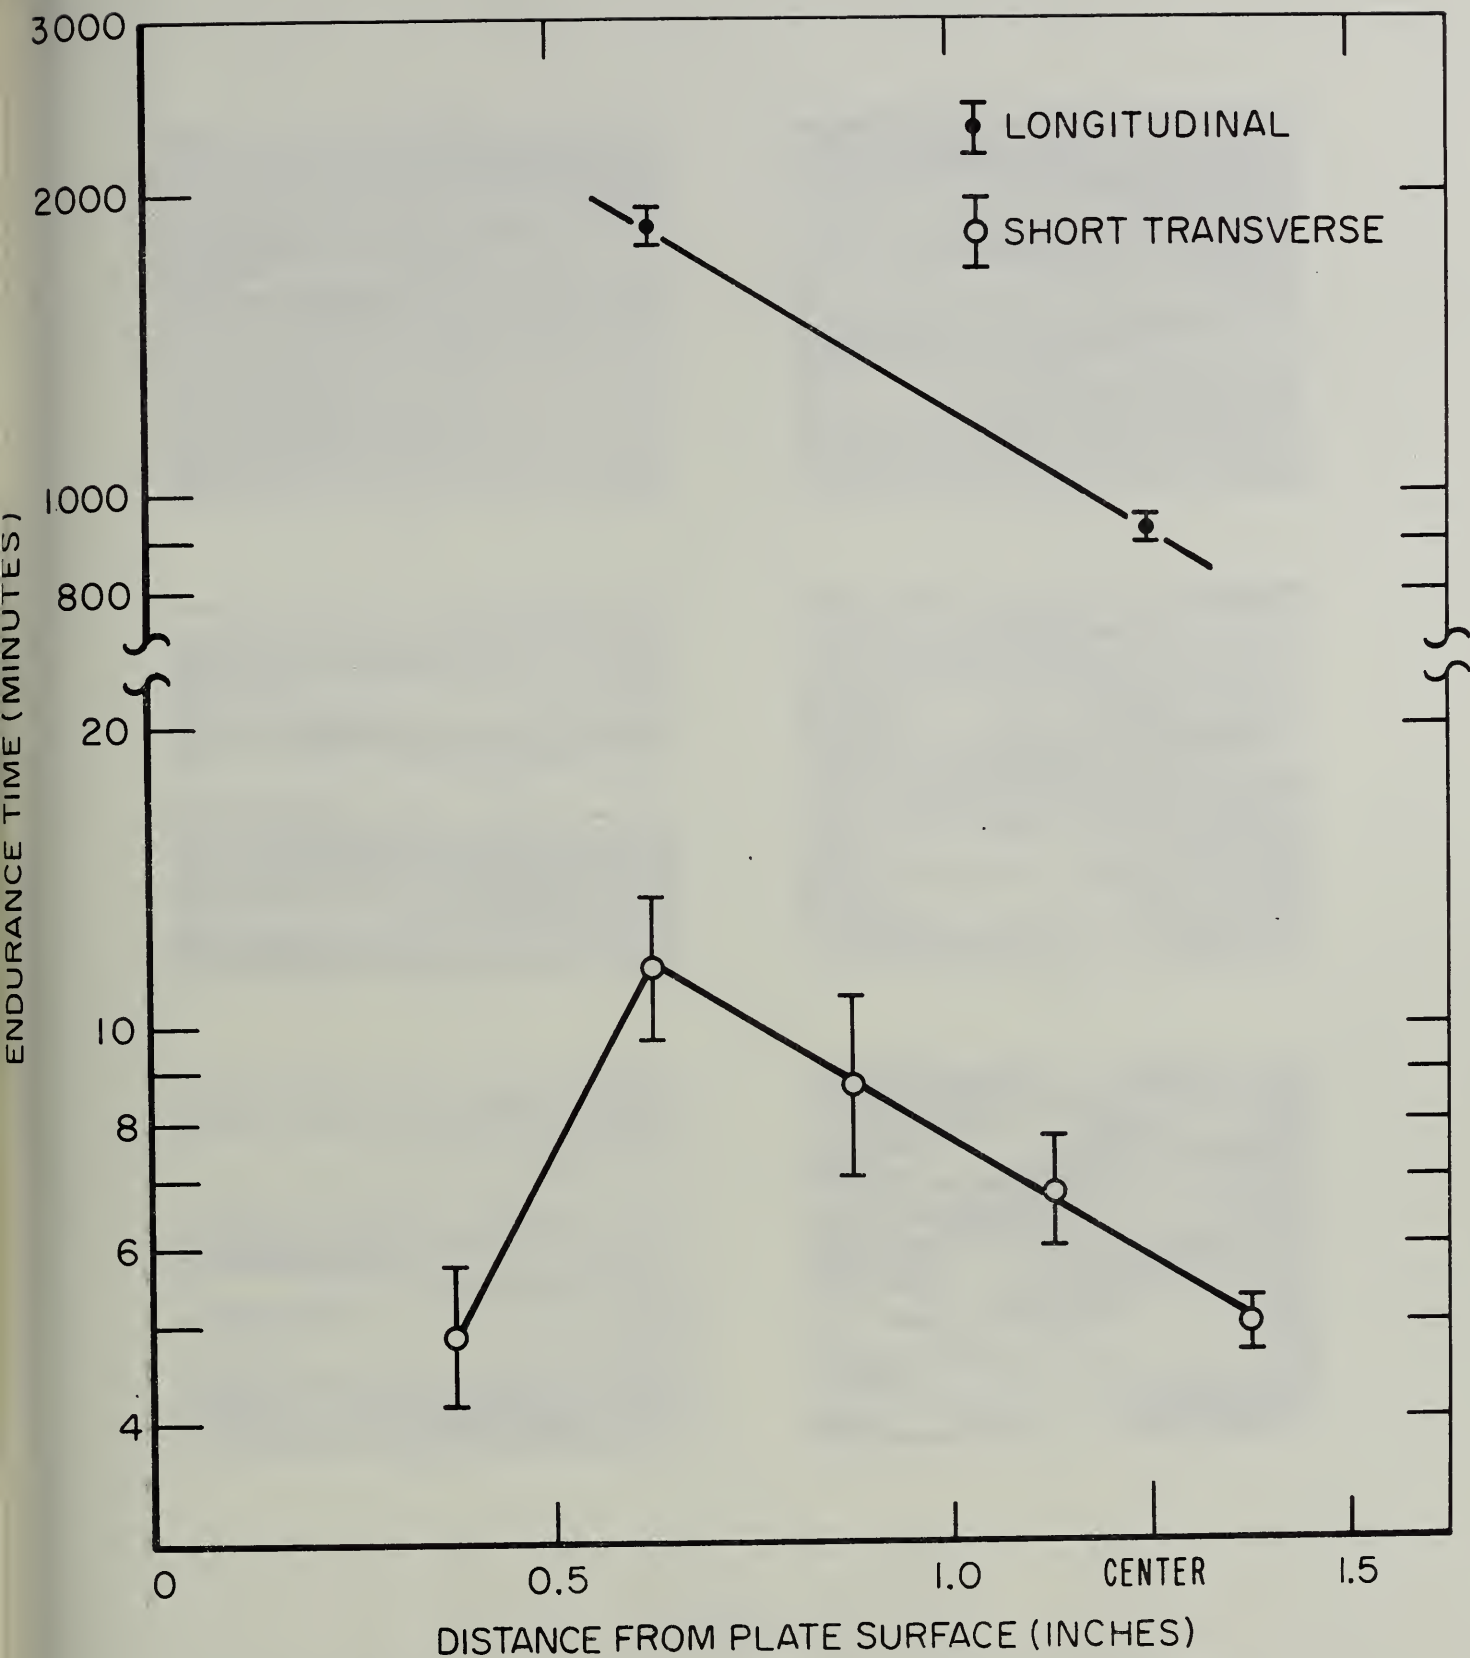
FIGURE 12

Stress corrosion endurance time versus depth of specimen in the plate for both short transverse and longitudinal specimens. Extremes of data points are the standard deviations based on the logarithms of endurance times.

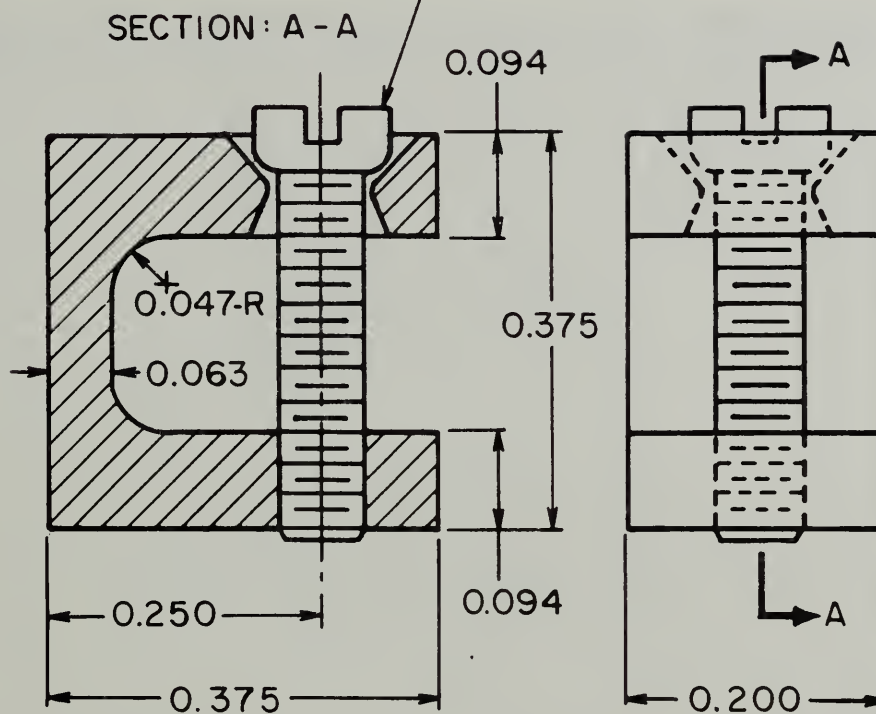
FIGURE 14

ALL DIMENSIONS IN INCHES
TOLERANCE ± 0.001 THROUGHOUT

Miniature tuning fork stress corrosion specimen.

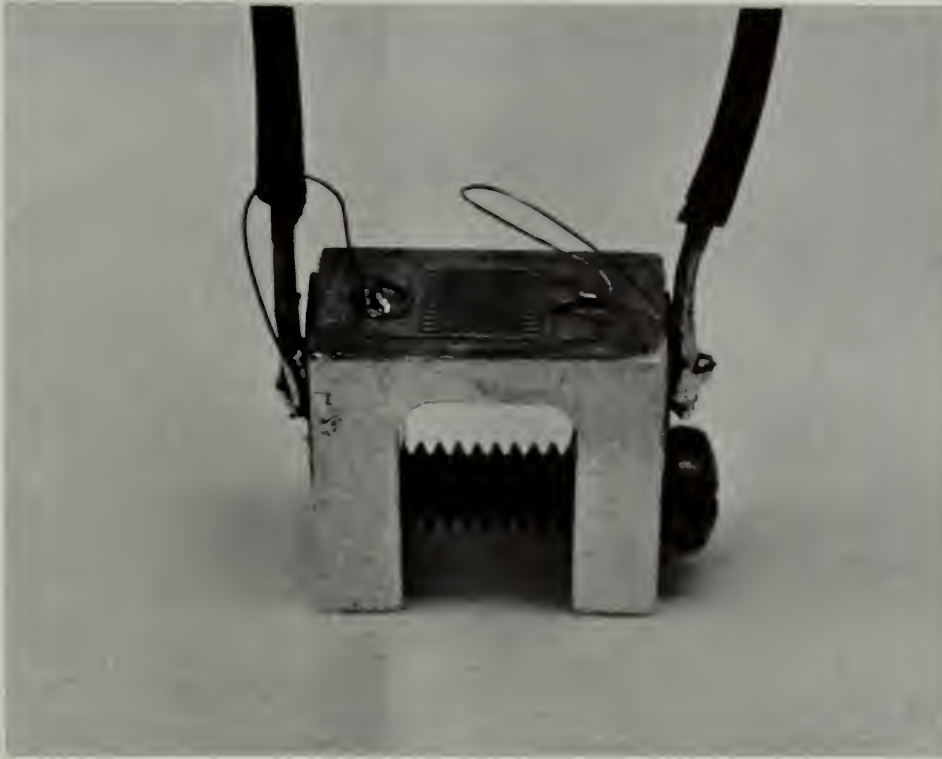
FIGURE 15

Miniature tuning fork specimen shown with strain gage in place
on stressed surface. X 5

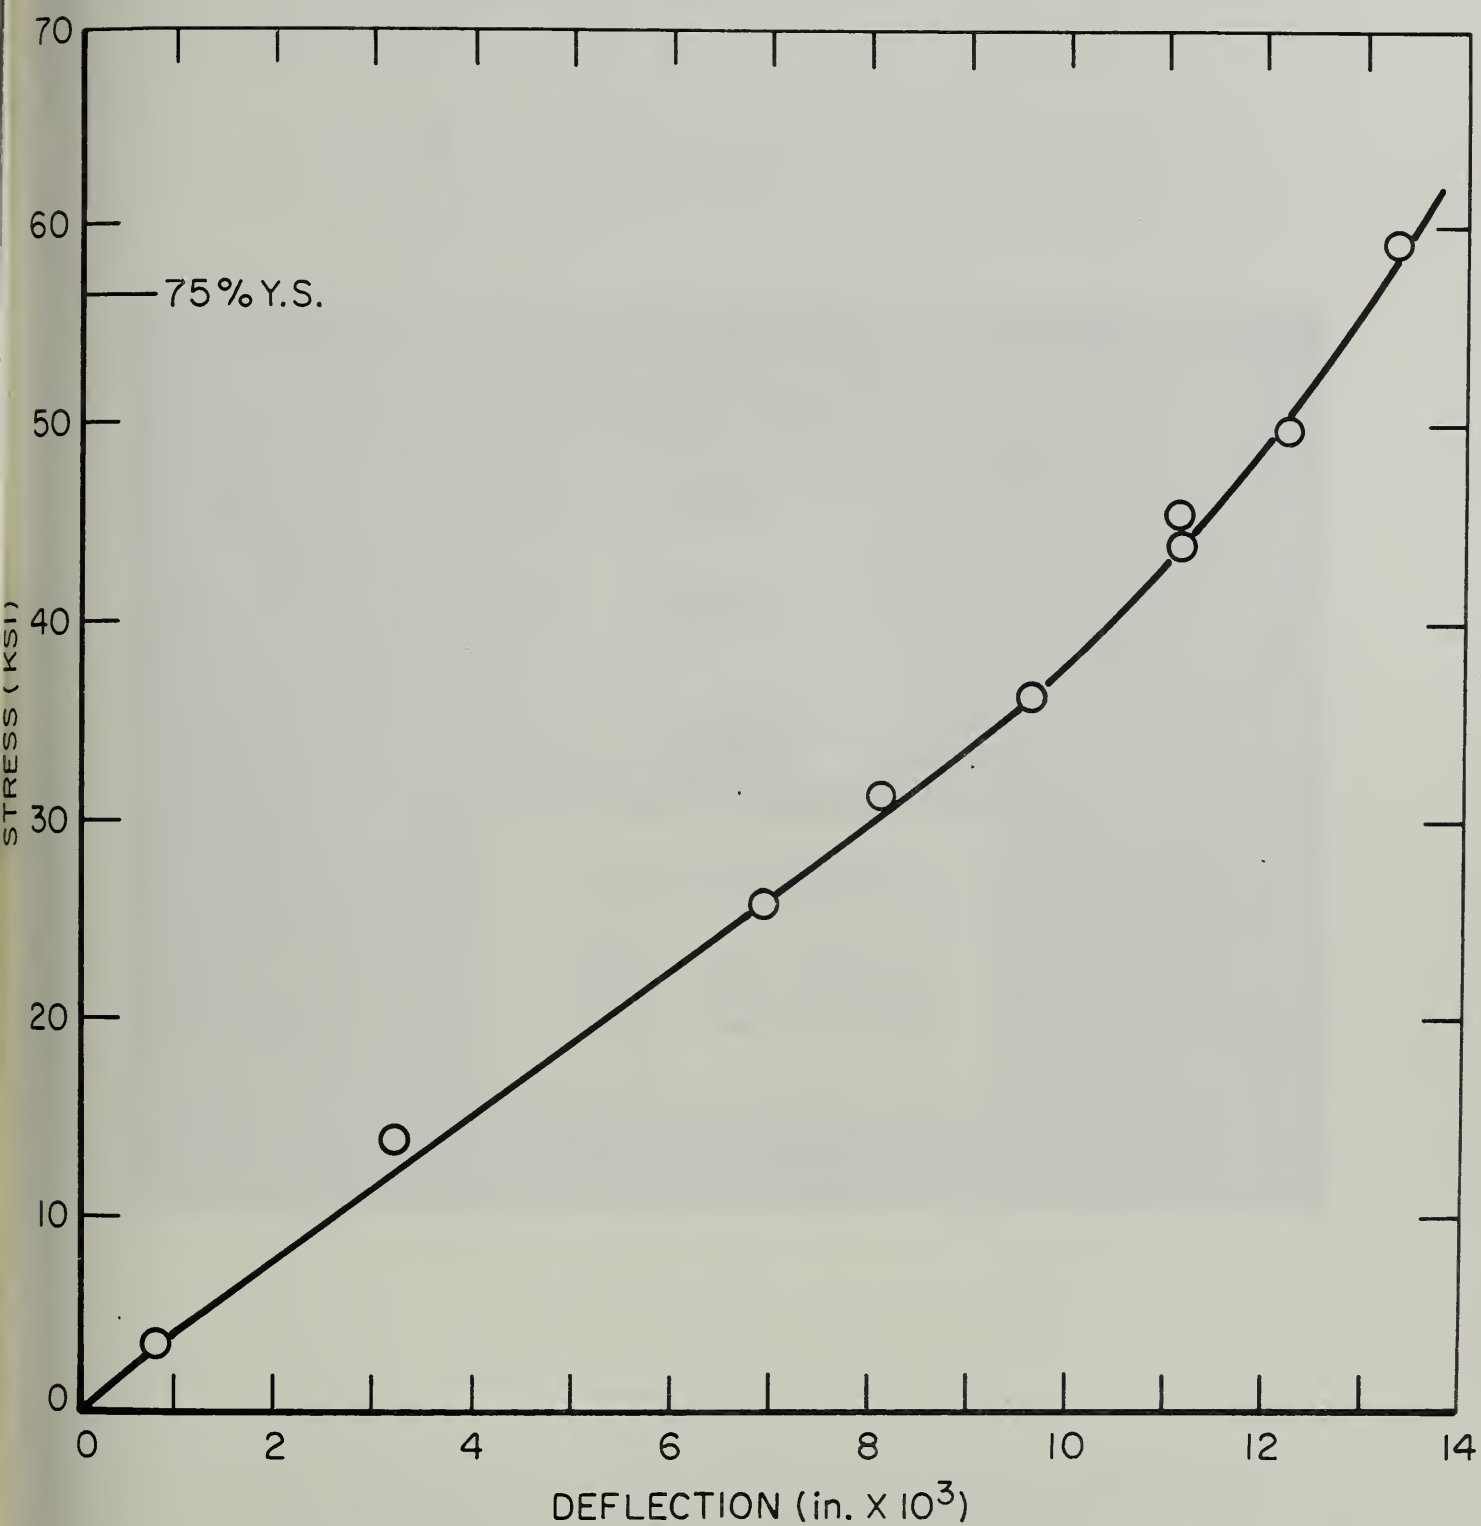
FIGURE 16

Stress-deflection curve showing the stress on the test area of the miniature tuning fork specimen versus the deflection at the screw end of the specimen.

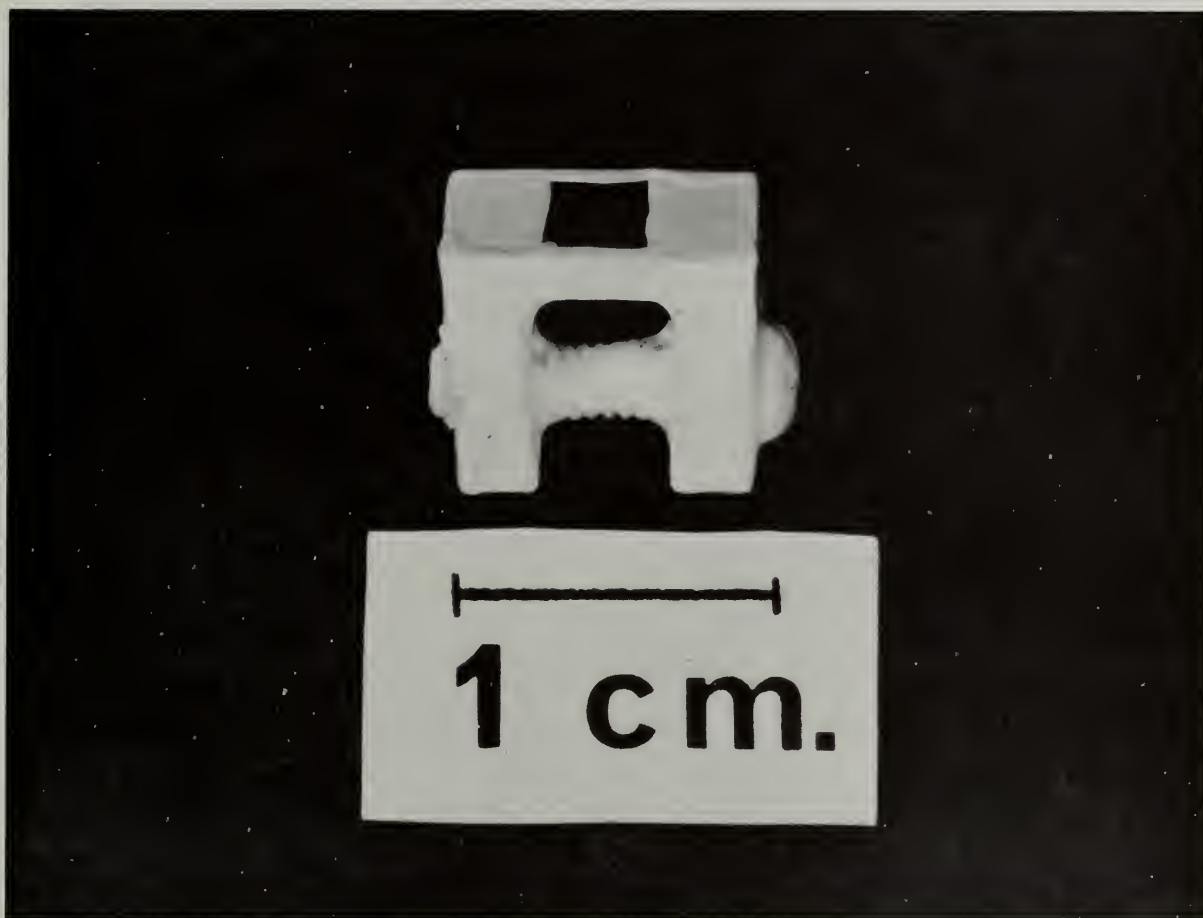
FIGURE 17

Miniature tuning fork specimen with the masking applied to all but a 2mm square area on the stressed surface. X 4

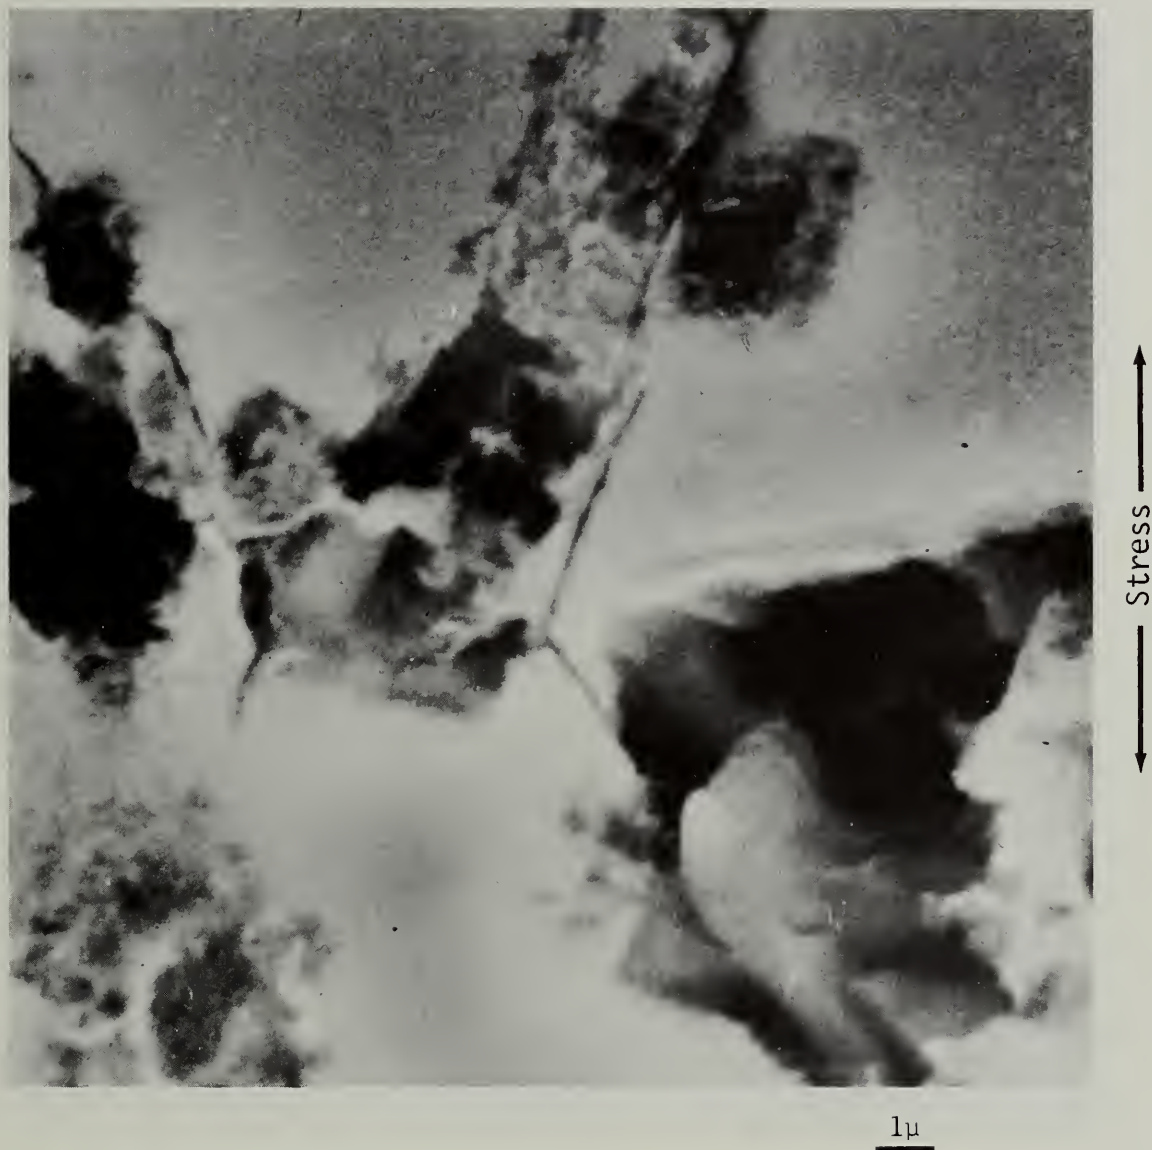
FIGURE 18

Scanning electron micrograph of a longitudinally stressed specimen after 30 seconds exposure to the chromate solution. Note stress corrosion cracks. X 7,500

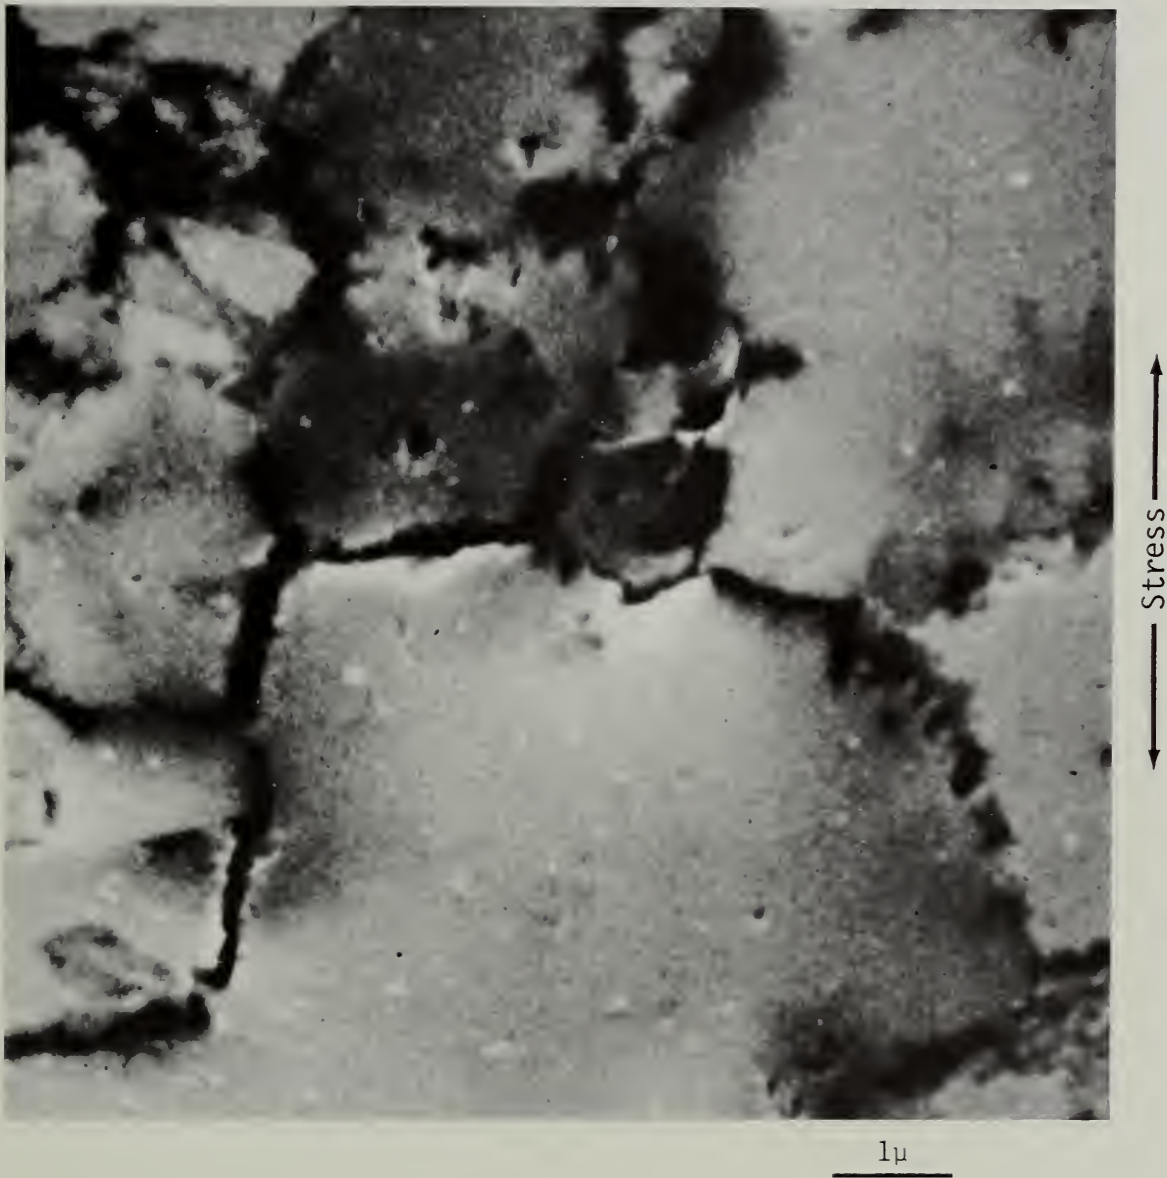
FIGURE 19

Scanning electron micrograph showing stress corrosion cracks on the surface of a longitudinally stressed specimen after 2 minutes exposure to the chromate solution. X 15,000

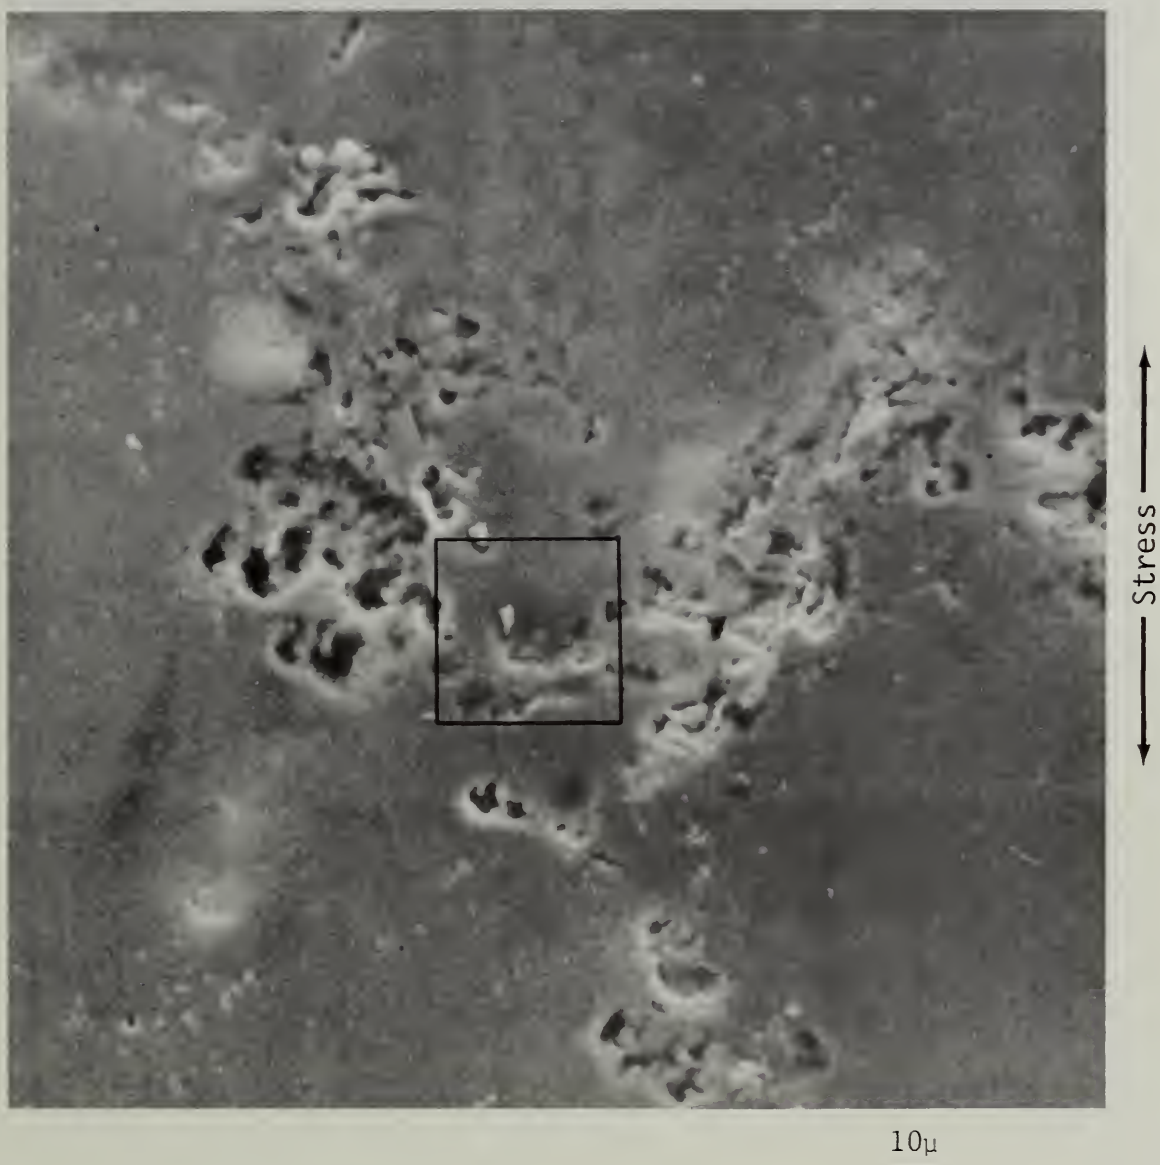
FIGURE 20

Scanning electron micrograph of a longitudinally stressed specimen showing stress corrosion cracks at the end of an elongated grain where the boundary is normal to the applied stress (enclosed area) after 5 minutes exposure to the chromate solution. Note the difficulty in observing the cracks at this low magnification. The enclosed area is shown at a higher magnification in Figure 21. X 750

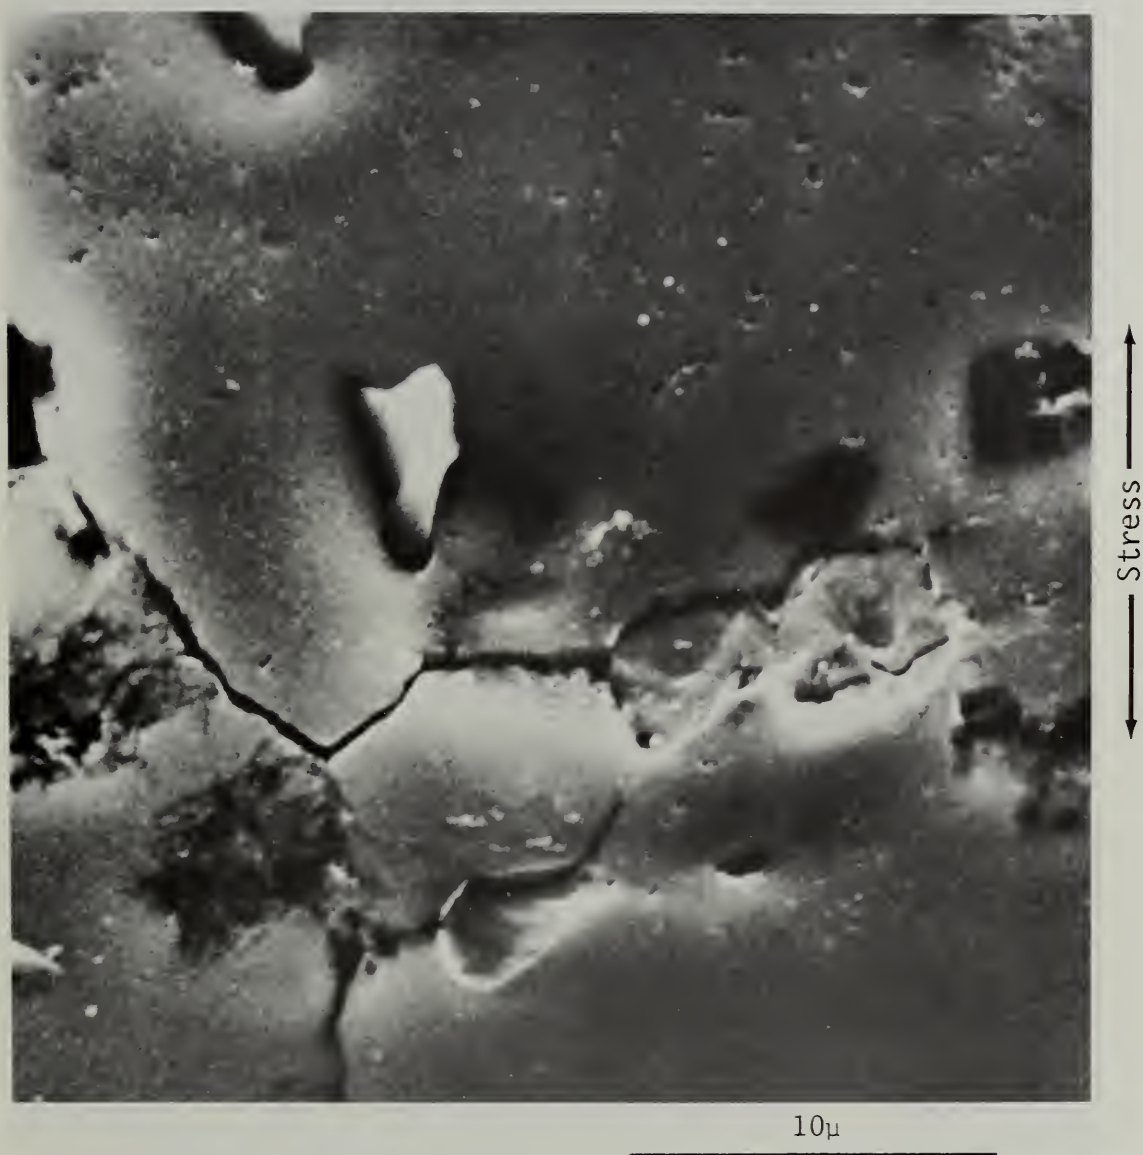
FIGURE 21

Scanning electron micrograph of the area marked off in Figure 20. Note that the cracking is primarily normal to the applied stress. X 4,500

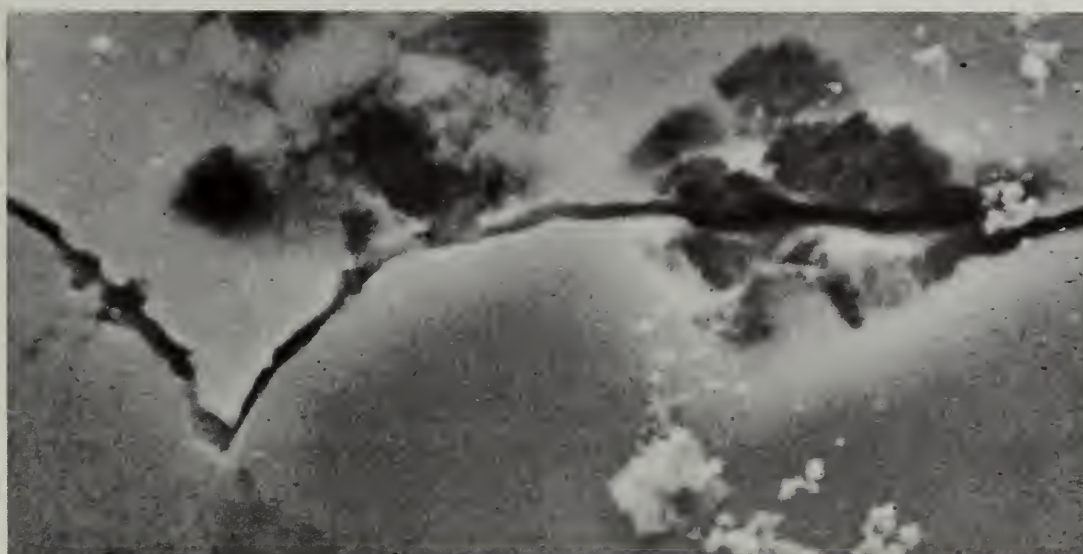
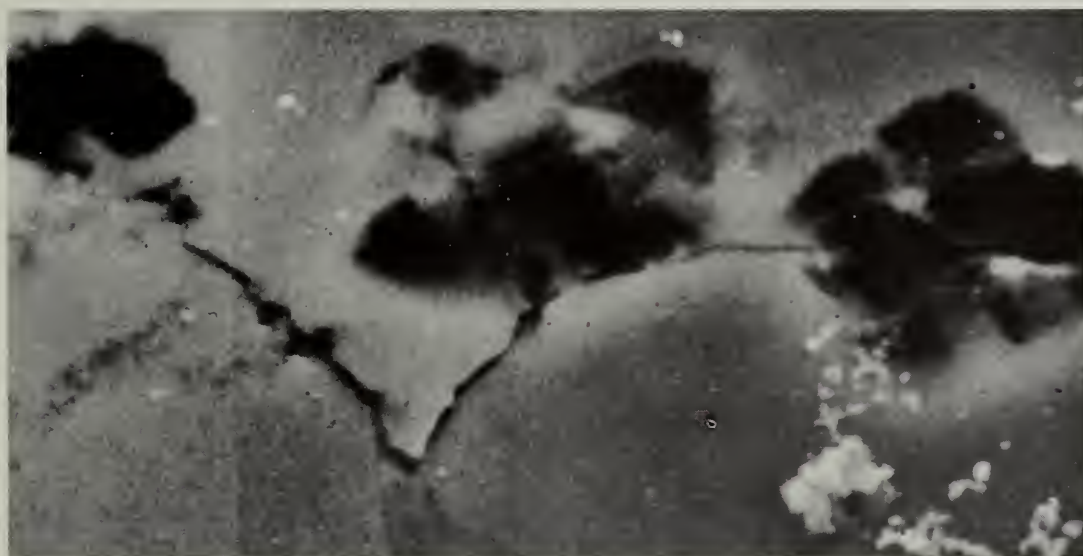
FIGURE 22

Scanning electron micrographs of a longitudinally stressed specimen after 7 minutes exposure to the chromate solution. The specimen is shown in both the stressed (a) and unstressed (b) states. Note closure of the crack in (b).
X 4,500

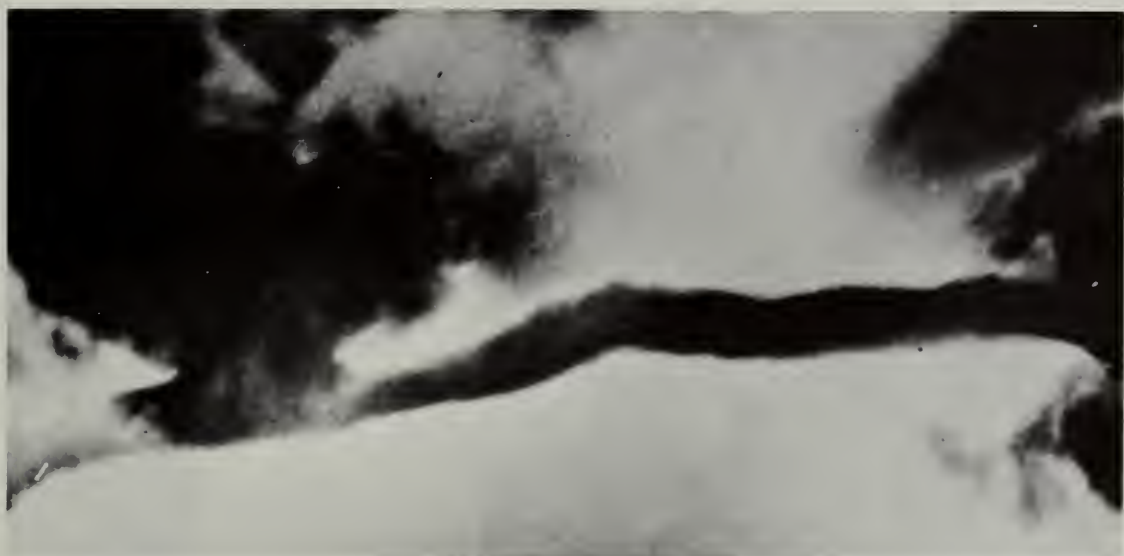
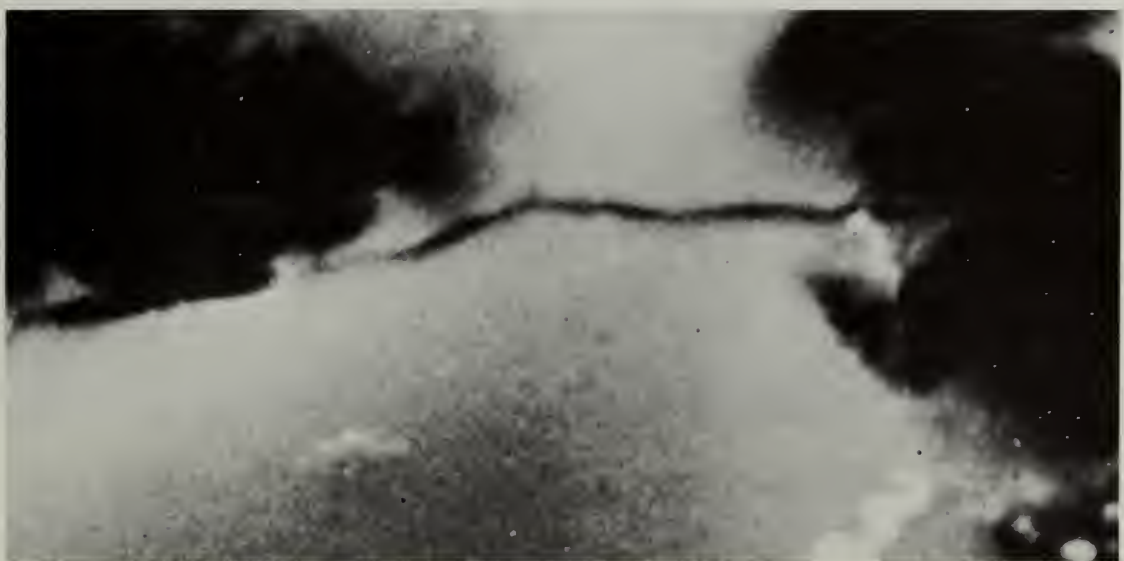
FIGURE 23

Scanning electron micrographs of areas shown in Figure 22 in the stressed (a) and unstressed (b) states. Note closure of crack in (b). X 15,000

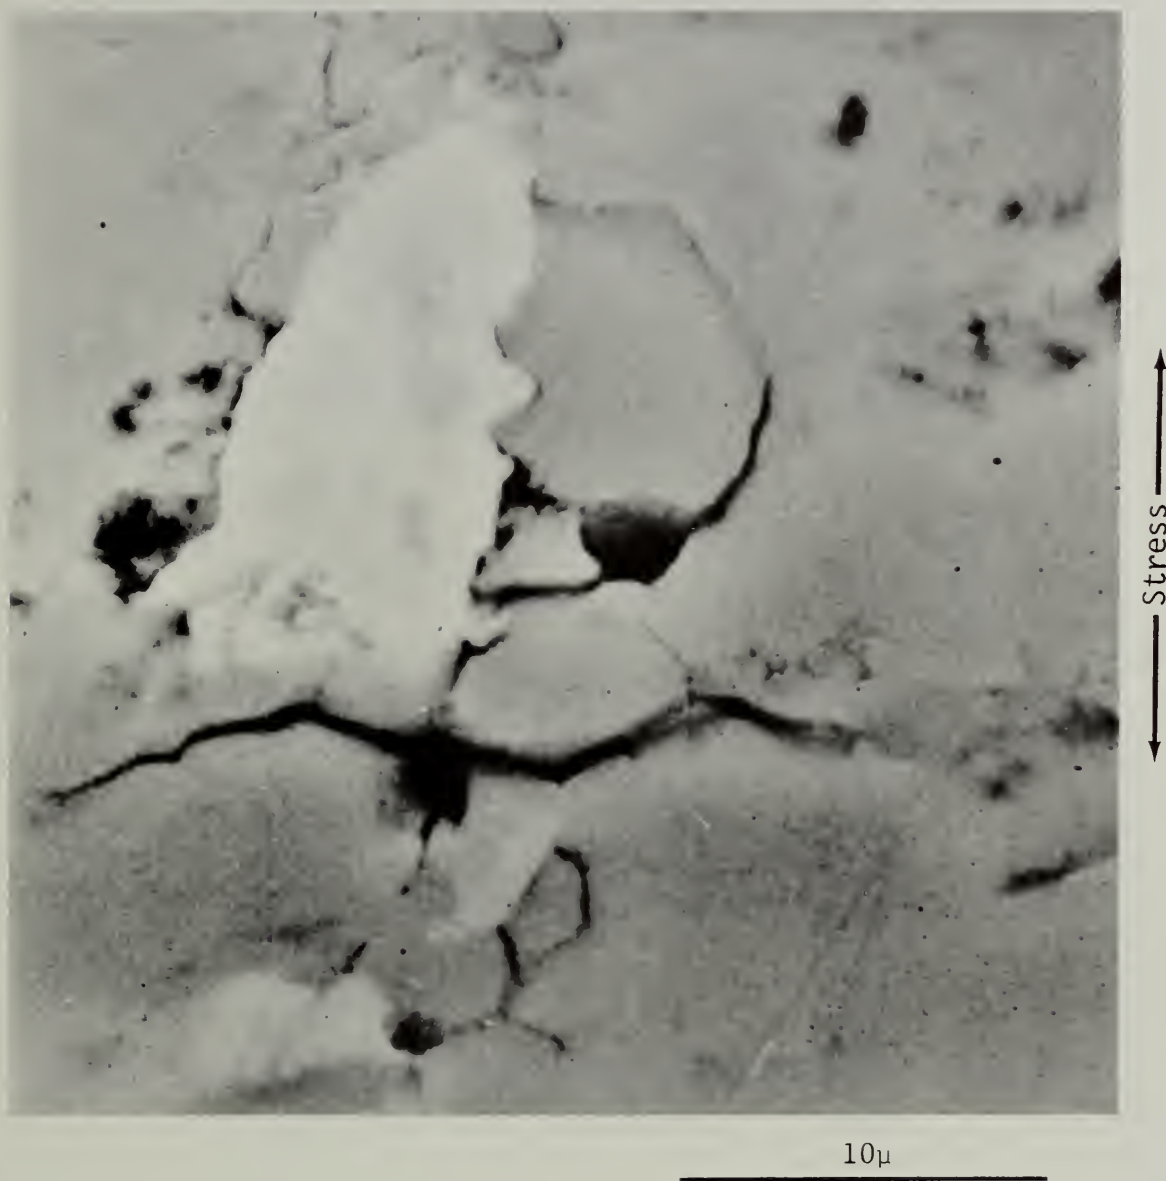
FIGURE 24

Scanning electron micrograph of a longitudinally stressed specimen after 16 hours exposure to the chromate solution. The general condition of the specimen was similar to that of a specimen after 7 minutes exposure with little additional crack propagation. X 4,500

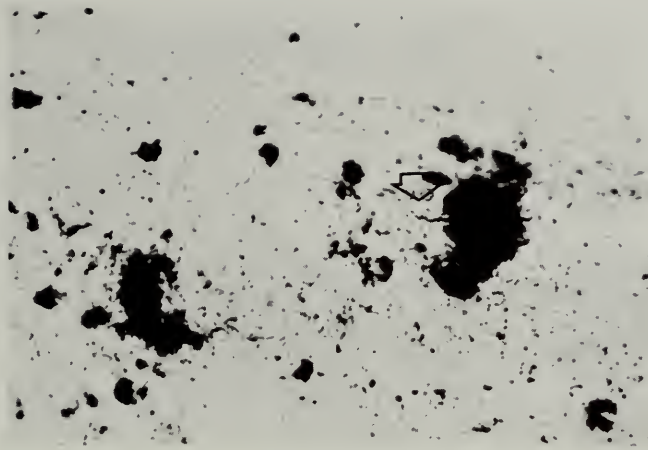
FIGURE 25

Stress corrosion cracks on short transverse (a) and longitudinal (b) specimens after 1 minute exposure to the chromate solution. Applied stress = 60 ksi. (a) - X2,000; (b) - X3,000

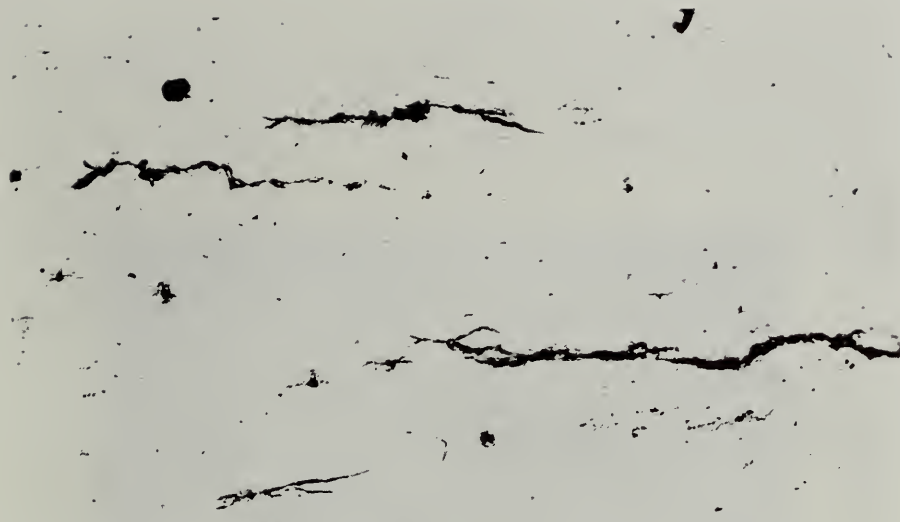
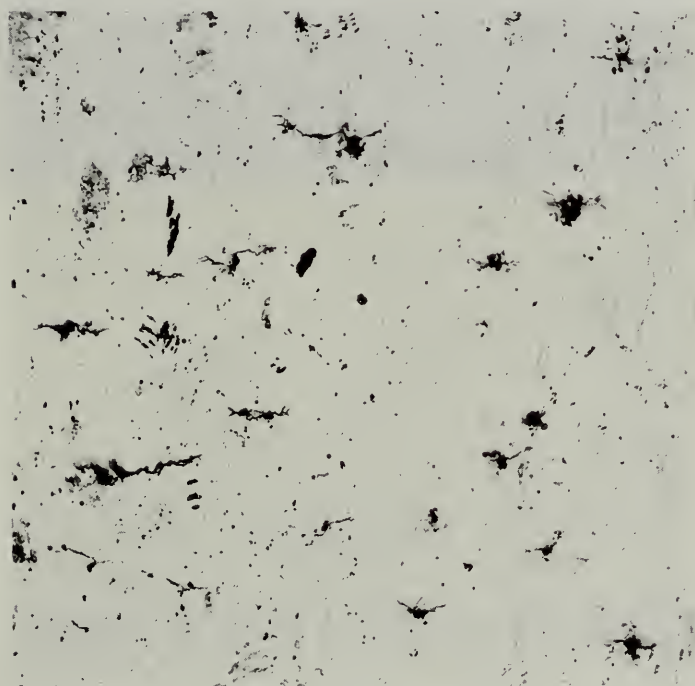
FIGURE 26

Stress corrosion cracks on short transverse (a) and longitudinal (b) specimens after 10 minutes exposure to the chromate solution. Applied stress = 70 ksi. X50

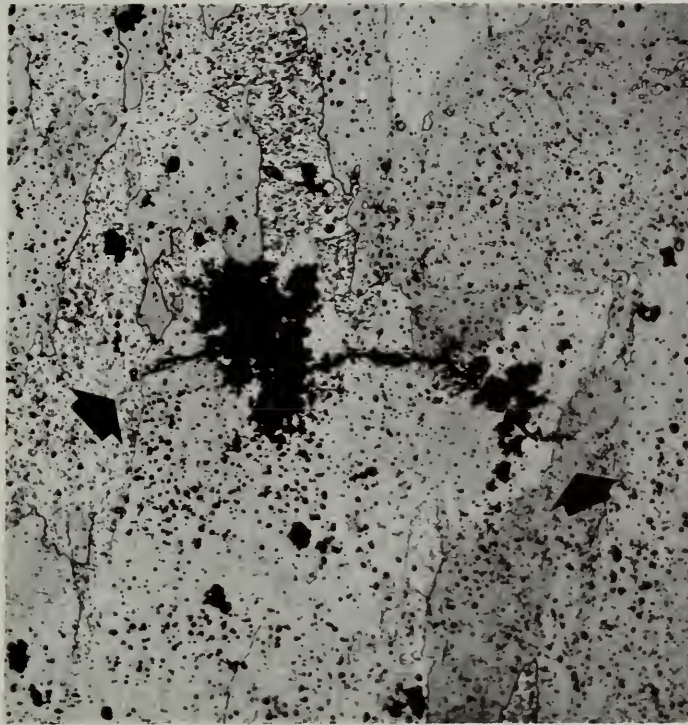
FIGURE 27

A stress corrosion crack on a longitudinally stressed specimen after 10 minutes exposure to the chromate solution. Note that cracking stops when unfavorable boundary is met. Applied stress = 70 ksi. Keller's etch. X200

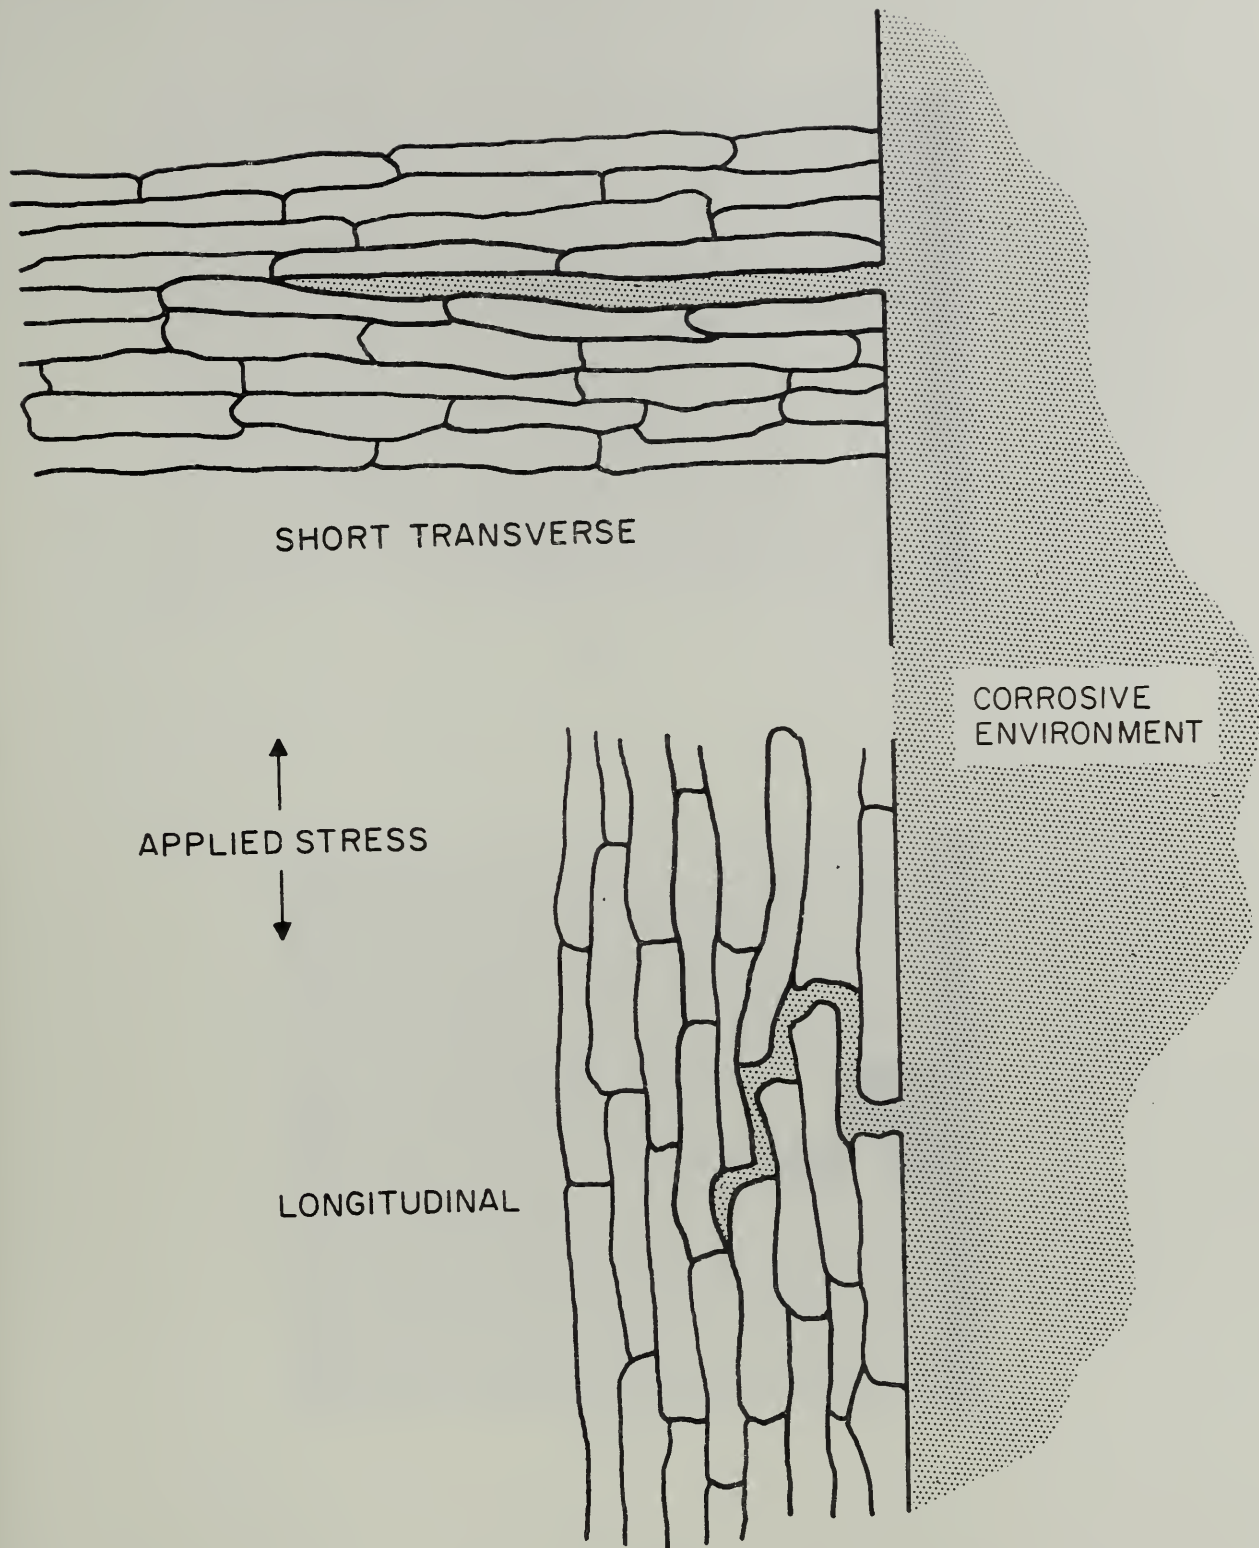
FIGURE 29

Schematic representation of stress corrosion crack propagation through an elongated grain structure when stressed in the short transverse and in the longitudinal directions. Note that in the short transverse specimen the crack may propagate in a plane that deviates very little, while the crack plane in the longitudinal specimen must deviate greatly from a plane normal to the applied stress.

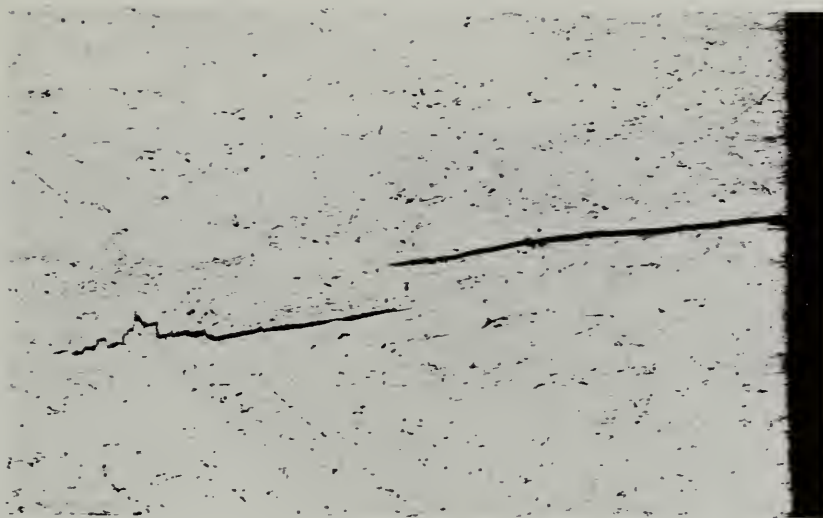
FIGURE 30

Photomicrographs of stress corrosion cracks in (a) a short transverse specimen, X75, and (b) a longitudinal specimen, X160. Note similarity to Figure 29.

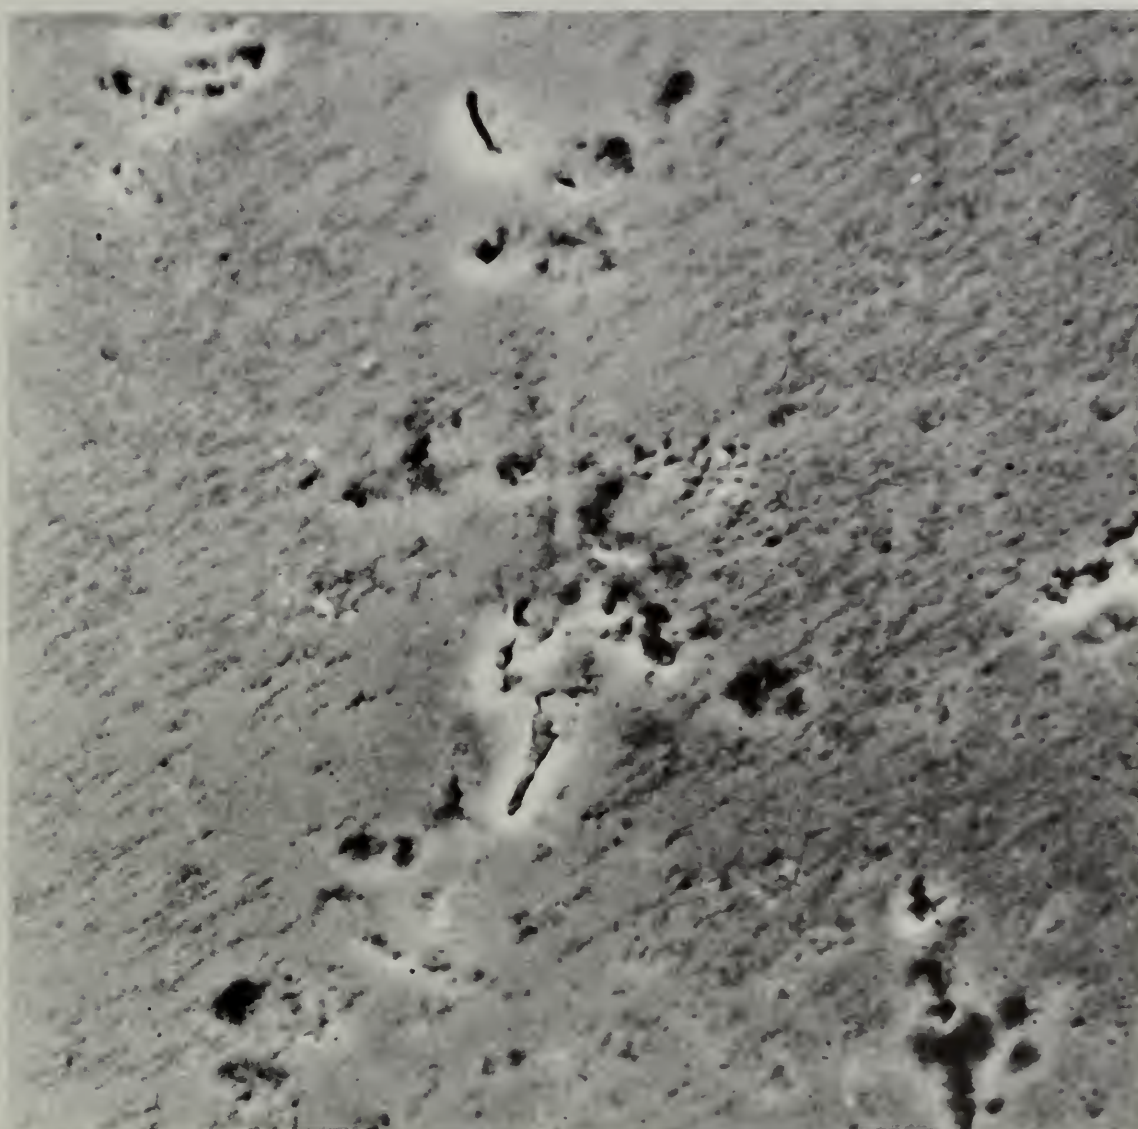
FIGURE 31

Scanning electron micrograph of the surface of an unstressed specimen exposed to the chromate solution for 10 seconds. Note the great amount of general pitting as compared to specimens corroded under stress. X 1,500
